# Manhole Inspection Summary

Manhole # S21AA\_040MH

Insp Date: 9/11/07 8:29 AM

**Location** Address: **1609 VINCENT ST**

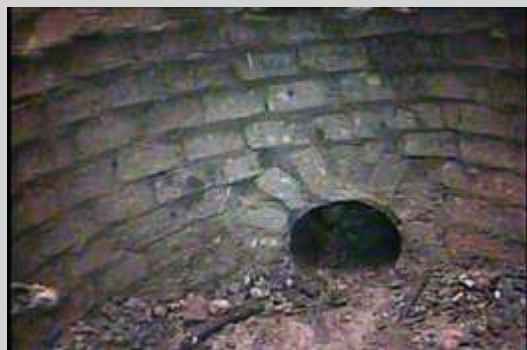
12 O'Clock Outflow

8 in. Circular Gravity Sewer  
Pipe Out @ 12 O'Clock

Pipe Height: **8.4** (in.) Rod and Bar (Angled)

Pipe Material: **Clay** ☐ Pipe Lined

Infiltration: **None** Pipe Seal Cond: **Sound**
